# Memo on Samurai Standard Detectors

## BDC spare(s)

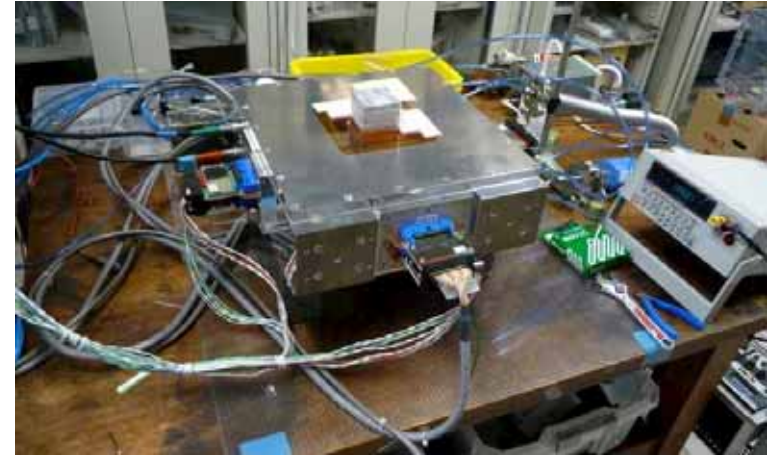
- Test in low-pressure box using  $i\text{-C}_4\text{H}_{10}$  [26-Sep~]
  - $P = 100$  torr
  - all planes connected,  $V_k = V_p$ 
    - $V_p$  trips sometimes at  $0.90\sim 0.95$  kV
    - $V_k$  can be applied up to  $1.25$  kV (plateau for MIP)
  - Y2 disconnected from HV chain,  $V_k = V_p$ 
    - OK:  $I_k, I_p < 10$  nA up to  $1.25$  kV (MIP sensitive)
- Status
  - Y2 plane still has some problems
    - no surface leak after ultrasonic cleaning
    - spark from wire kink or HV lead ?
  - Other 7 planes are OK
  - plan
    - disassemble and check Y2 plane again

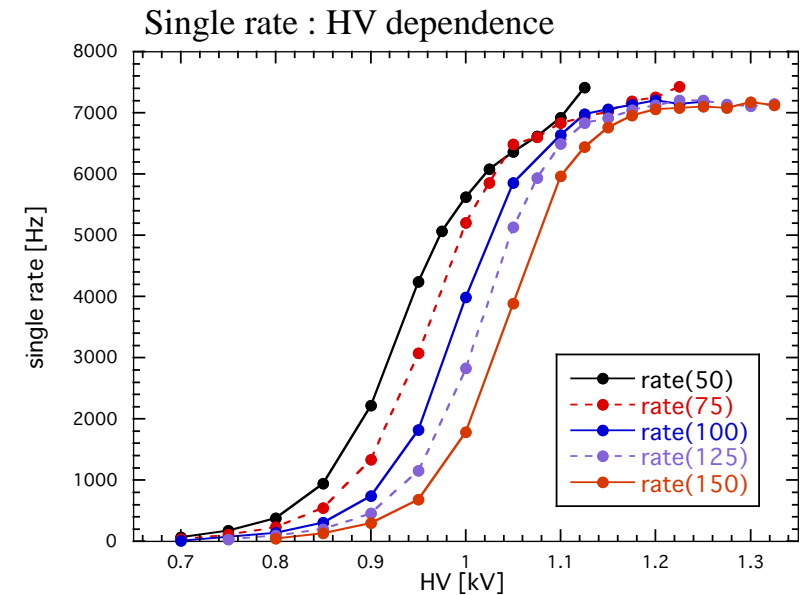
- Transported from Riken to Tohoku [17-Sep]
- HV conditioning using P10 [17-Sep ~ 26-Sep]
- Test in low-pressure box [27-Sep]
  - conditions
    - ASD: 80nsec,  $V_{th}=-0.4$  V
    - $i-C_4H_{10}$  : P= 50 ~ 150 torr
    - $V_k = V_p$
    - collimated  $\beta$ -rays [MIP]
  - single rate check
    - very stable, OK
    - MIP sensitive for P > 100 torr
  - leak current
    - $I_k, I_p < 10$  nA at highest HV applied
  - All channels alive : checked by visual scaler
- Status
  - BDC4 is in a good condition : OK
  - BDC4 + low-pressure box : one spare BDC ready
